MNMM Fatal 2005-07

- Machinery
- April 1, 2005 (Virginia)
- Lime Operation
- Mechanic
- 50 years old
- 30 years experience

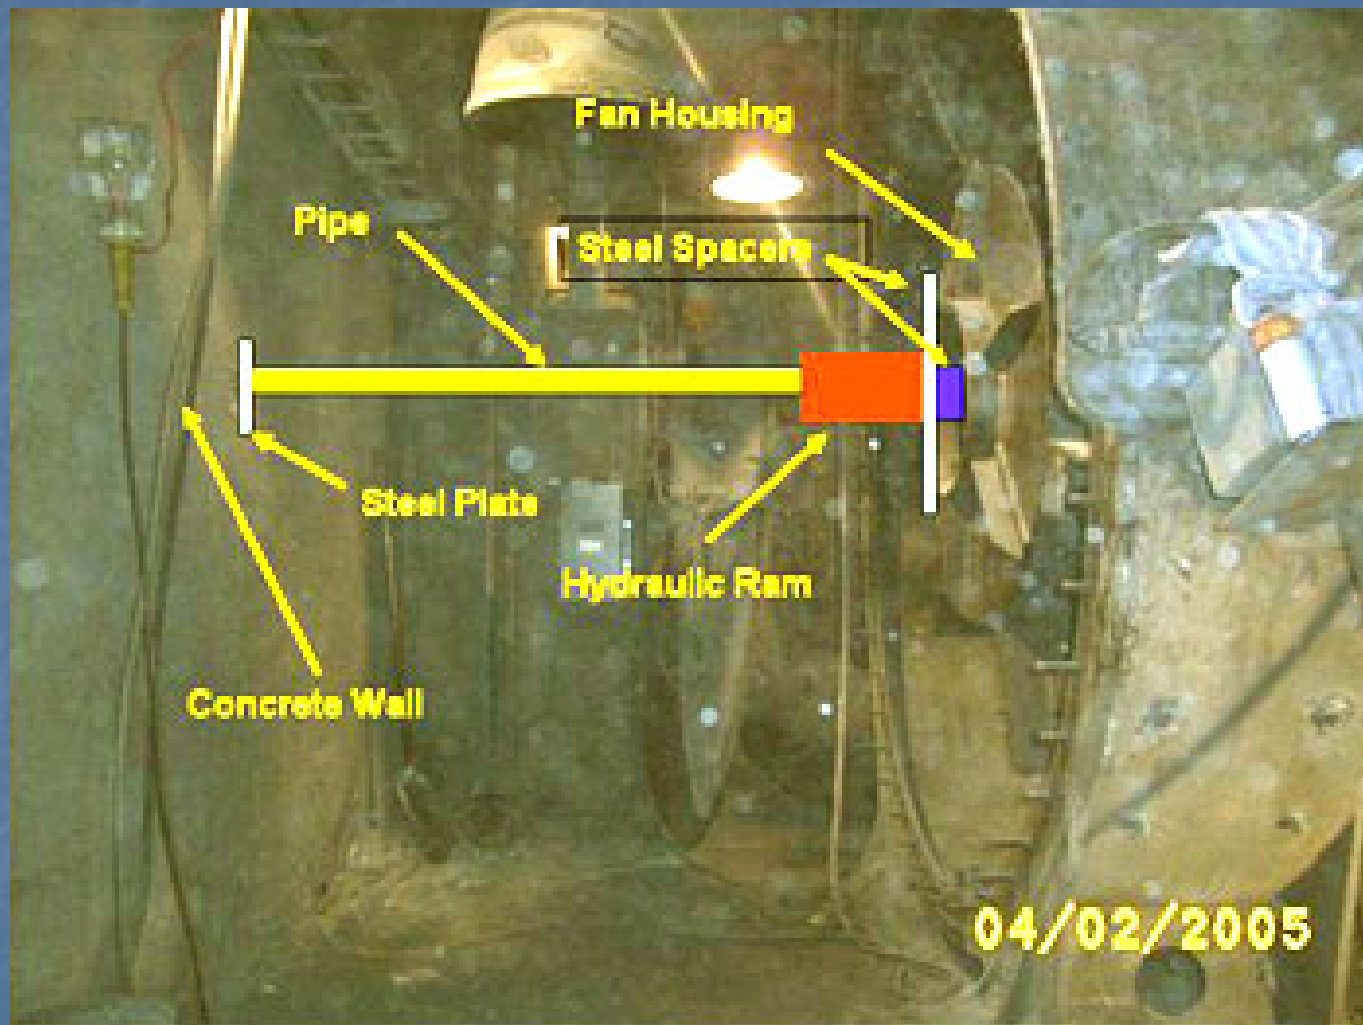
- The victim and a co-worker were attempting to install a fan housing on a coal mill. They had positioned a steel pipe against a concrete wall to support an electrically-powered, hydraulic ram that was utilized to push the housing into position. During this process, the pipe dislodged and struck the victim.

- The accident was caused by the failure to evaluate the work procedures, identify all possible hazards, and establish safe procedures to install the fan housing. The steel pipe was used beyond the designed capacity intended because the force applied bent the pipe, causing it to kick out.

- Policies, standards, and controls were inadequate. The company had not developed safe work procedures to support the porta-power and hydraulic ram in conjunction with a steel pipe and combination of spacers. The task could not be performed safely because the pressure applied by the ram exceeded the designed capacity of the pipe.
- None of the components were assembled or supported on a stable base. Miners were required to manually support the components during the installation process.

- Conduct a Risk Assessment before beginning a task, to evaluate the work procedures, identify all possible hazards, and ensure steps are taken to safely perform the task.
- Establish policies that ensure procedures are developed and followed to safely complete repair tasks.
- Ensure the proper equipment is utilized so that equipment components are blocked to prevent hazardous movement.
- Ensure that miners are not positioned in areas where they are exposed to hazards resulting from a sudden release of energy.
